FEDERAL UNIVERSITY OF SÃO CARLOS  
CENTER FOR EXACT SCIENCES AND TECHNOLOGY  
POSTGRADUATE PROGRAM IN CIVIL ENGINEERING

FLEXURAL BEHAVIOR OF CORRODED STEEL BEAMS WITH AND  
WITHOUT WEB OPENINGS: EXPERIMENTAL, ANALYTICAL, AND  
NUMERICAL INVESTIGATION

A thesis submitted to the Faculty of Postgraduate Studies in fulfillment of the requirements for the defense of the Doctor of Philosophy degree in Civil Engineering.

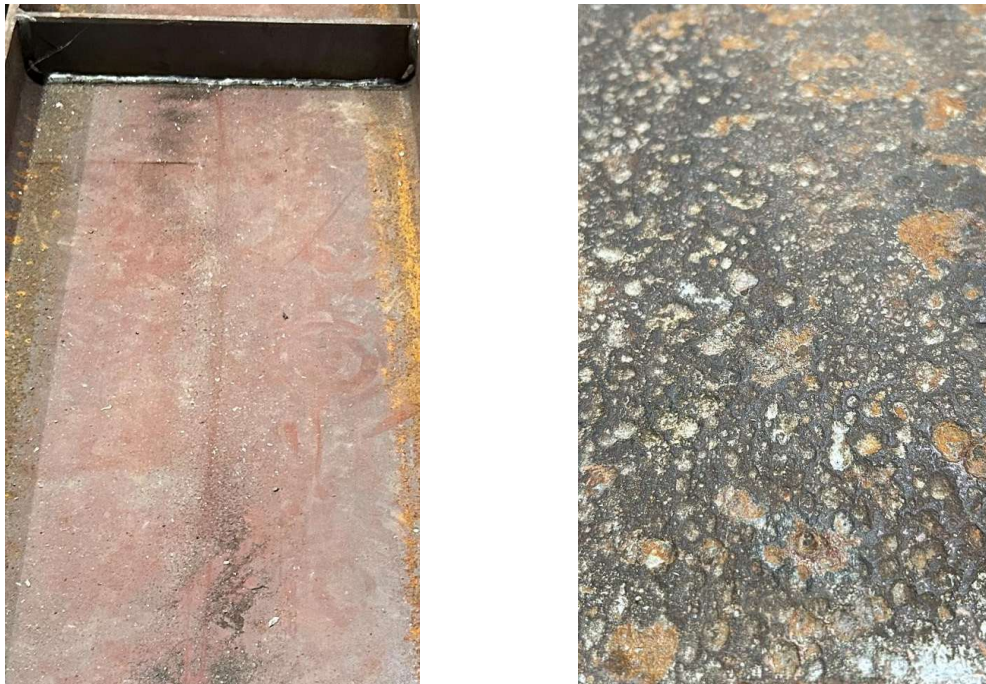
Figure 01 - Surface of non-corroded and corroded beam

01b illustrate the effect of pitting on the web surface of the same steel beam before and after corrosion.

(a) Surface of non-corroded beam

(b) surface of corroded beam.

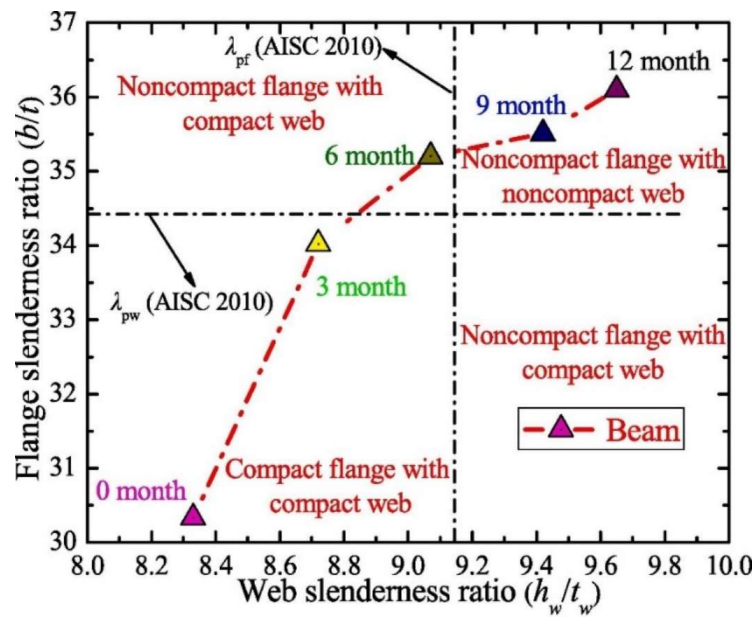
Figure 03. Section classification of steel beam with different degrees of corrosion.

section, inevitably decreasing the flexural capacity of steel members. Therefore, it is crucial to understand the degradation of flexural capacity in corroded steel members and to develop a design method for the flexural buckling capacity of existing corroded steel structures.

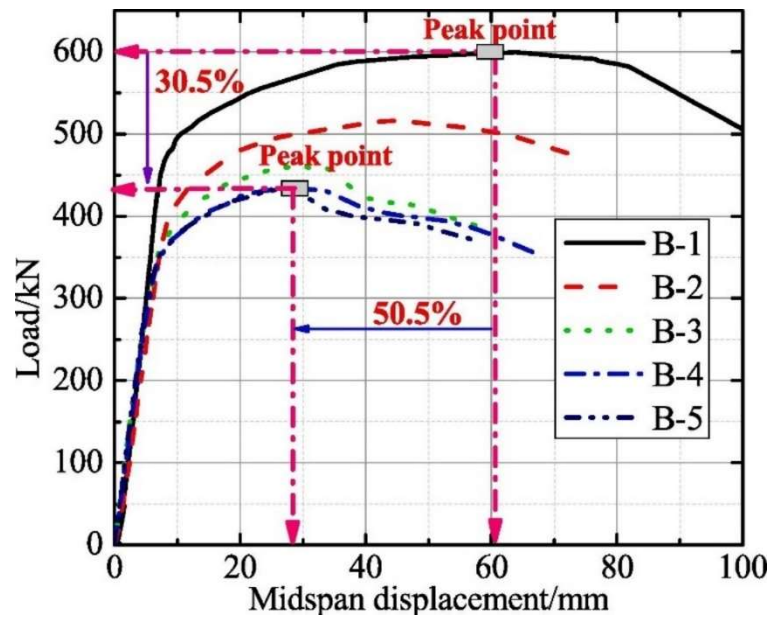
Figure 04. The load–displacement curve of the corroded steel beams.

Additionally, Figure 04 presents the load–displacement curves of the corroded steel beams. As the degree of corrosion increases, the ultimate loads of the specimens gradually decrease, and the corresponding deflection values decrease significantly. Corrosion diminishes the steel beam's capacity for inelastic deformation, which leads to a reduction in rotational capacity, as noted by Zhang (2021). For instance, the ultimate load of the non-corroded specimen B-1 is 601.23 kN, with a corresponding mid-span deflection of 60 mm. However, when the corrosion ratio reaches 16.88%, the ultimate load of specimen B-5 drops to 429.3 kN, and the corresponding mid-span deflection reduces to just 28 mm. As the corrosion level increases, the ultimate load and mid-span deflection are reduced by 30% and 50%, respectively.

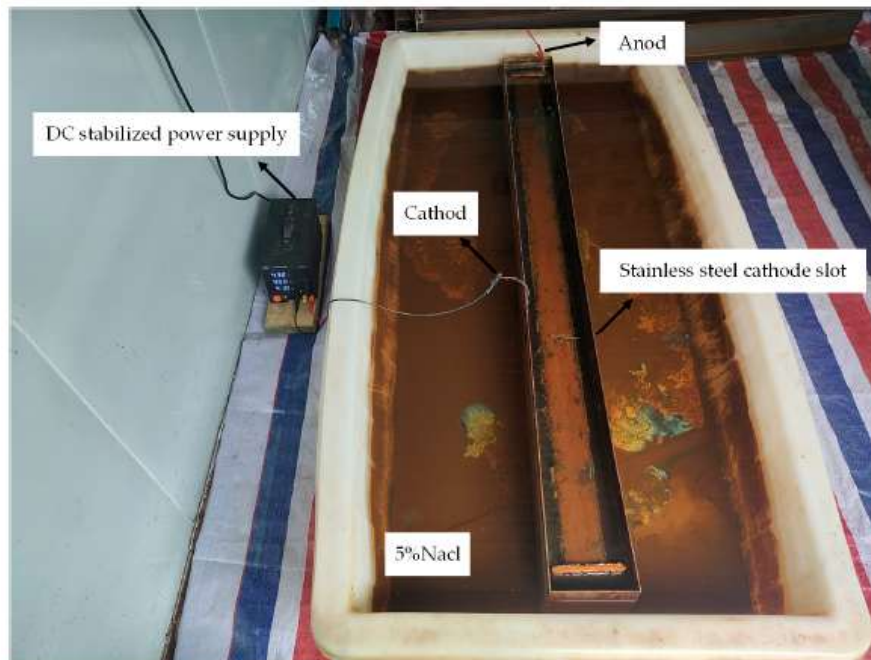
Figure 06. Electrochemical corrosion test.

To obtain the prescribed corrosion levels, the beams were immersed in an electrified accelerated corrosion tank containing a 5% NaCl solution, as shown in Figure 06. This procedure was adopted to promote a more uniform corrosion pattern along the steel surface and to provide better control over the degradation process. In addition, steel current-conducting plates were welded to both ends of the specimens in order to reduce possible irregularities during immersion. According to the authors, this measure was necessary to avoid non-uniform corrosion that could result either from contact between the lower flange and the bottom of the tank or from the direct connection of electrical wires to the beam surface. In this way, the experimental setup shown in Figure 06 was designed to ensure a more consistent corrosion process and, consequently, a more reliable assessment of its influence on beam stability. Beams investigated in this study, with emphasis on the influence of pitting corrosion on strength, stiffness, strain evolution, and failure mode. The finite element model was implemented in ABAQUS and includes the definition of mesh discretization, boundary conditions, initial geometric imperfections, constitutive modelling of steel, and residual stress patterns. In addition, a stochastic procedure based on a correlated Gaussian random field was adopted to reproduce the spatial variability of thickness loss caused by corrosion.

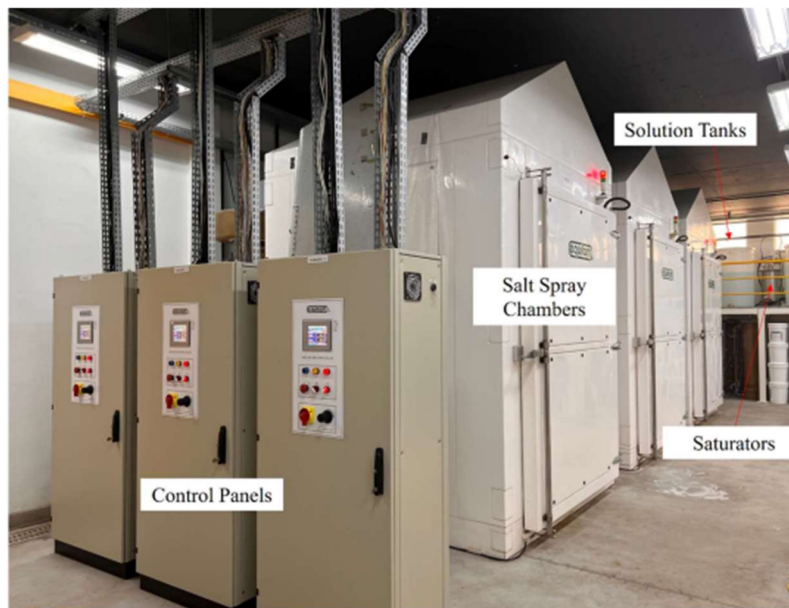
Figure 11. Salt-spray chambers.

A large-scale chamber, Figure 11 was utilized with the aim to evaluate degradation mechanisms in specific environments at varying aging rates and collect data to predict the behavior of the beams after 6 months. The selected temperature was 55°C. The salt-spray accelerated aging tests were conducted with specimens exposed to approximately 4068 hours (6 months) of continuous aging inside salt-spray chambers.

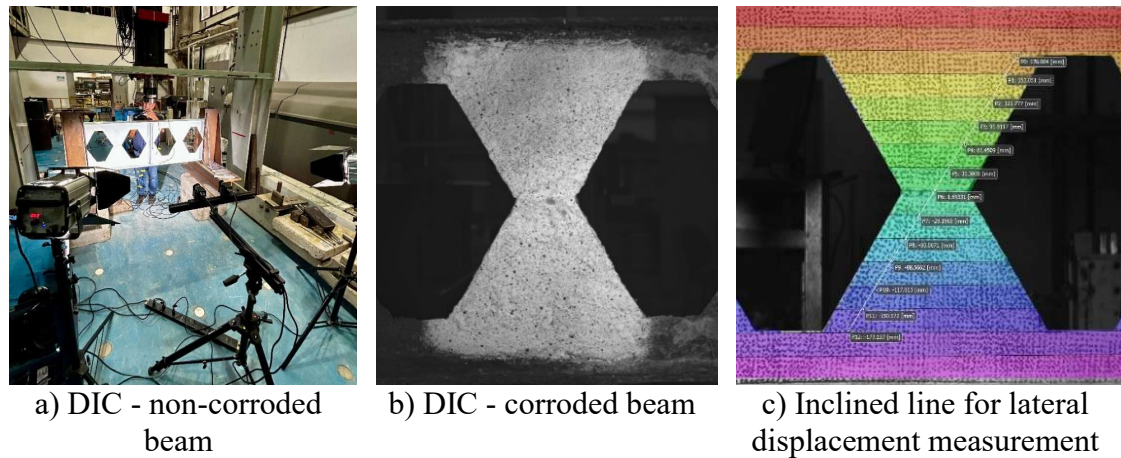
Figure 23 - Digital image correlation setup and analysis.

Figure 23a and 23b shows the three-dimensional DIC setup used to monitor full-field displacements and strains throughout the loading process. Prior to testing, the surface of non-corroded beams was prepared by applying a speckle pattern using a textured roller over a white matte background, whereas for corroded beams, the pattern was sprayed with a random black speckle over a white matte coating to ensure uniform contrast on the rough surface. Two 5-megapixel charge-coupled device cameras were positioned with a convergence angle of approximately  $25^\circ$  under uniform LED illumination. Stereo calibration was performed using a VIC-3D target to correct optical distortions. Images were captured every 10 s and processed with VIC-3D software to obtain displacement and strain fields. The lateral displacements of the web-post were extracted along an inclined line parallel to the open edge, as shown in Figure 23c, selected due to field symmetry. To capture the variability in pit depth, 3D surface profiles of the upstream web were acquired prior to loading, from which pit depths were measured and fitted to a log-normal distribution to determine the mean and SD. This experimental procedure follows DIC practices validated by Ma et al. (Ma et al., 2024) and Ma et al. (Ma et al., 2020).
